Current Situation and Issues of Myanmar's Bridge Work

September, 2012

Japan Infrastructure Partners (JIP)

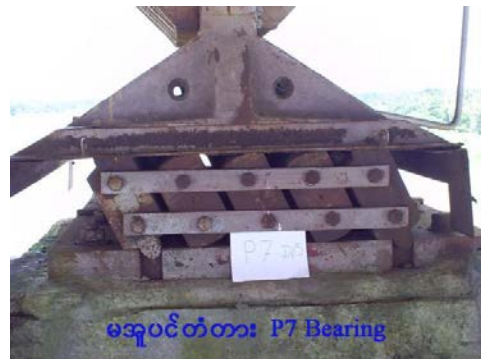
Photo-3.6 Deformed shoe of the Maubin Bridge (2)

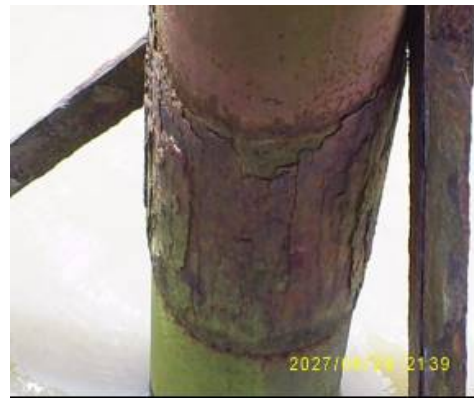
Photos - 3.7-10 show the situation of a Bailey bridge and its pipe pier in the Irrawaddy delta area. Apparently, the pier of a similar bridge collapsed after observation by the inspection team. This region is prone to seawater intrusion, and it seems that the corrosion of a steel pipe caused the pier to collapse. Apparently, just after it collapsed, this bridge was reconstructed as a concrete bridge.

Photo-3.10 Deterioration of pipe

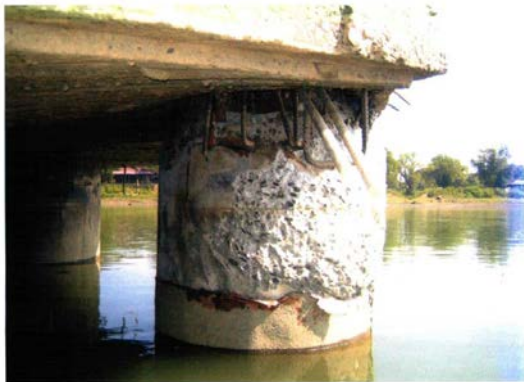
Photos - 3.11 - 13 and Figure - 3.1 show defective construction work and later repairs to the upper section of cast-in-place concrete pile of the bridge foundations widely used in Myanmar.

Photo-3.11 Section of poor execution at the pile top

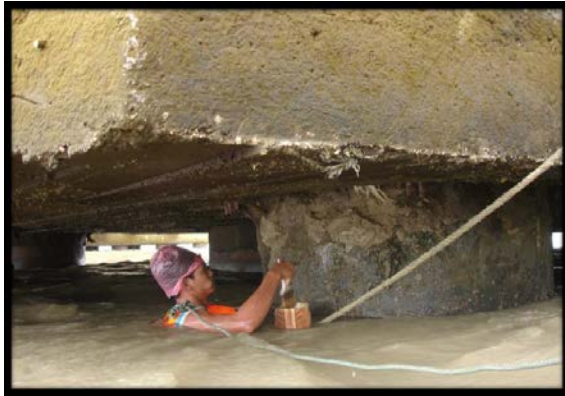
Photo-3.13 Repair of pile top

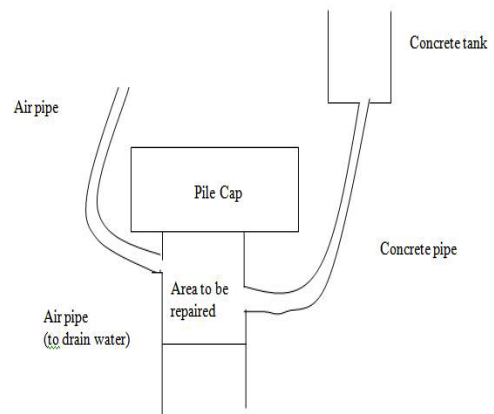
Figure-3.1 Method of repair at a section of poor execution at the

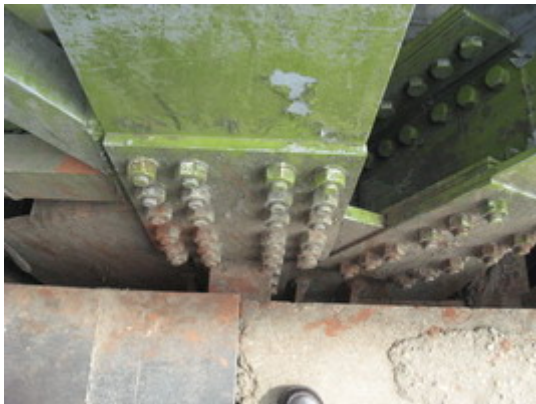
Rubbish has collected at the panel points of the trusses, and such a state is susceptible to corrosion (Photos 4.15 & 16). Preventing corrosion of truss panel points was suggested as a crucial maintenance item.

Photo-4.15 Panel point of truss

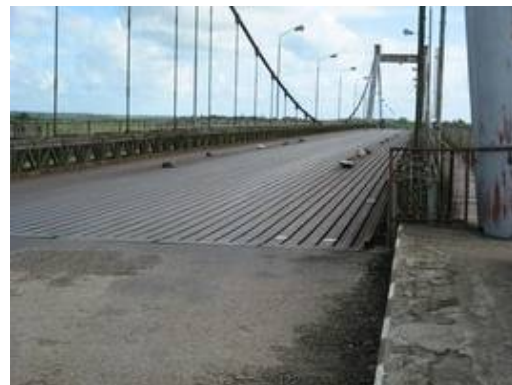
Photo-4.20 Rocks put on the road surface

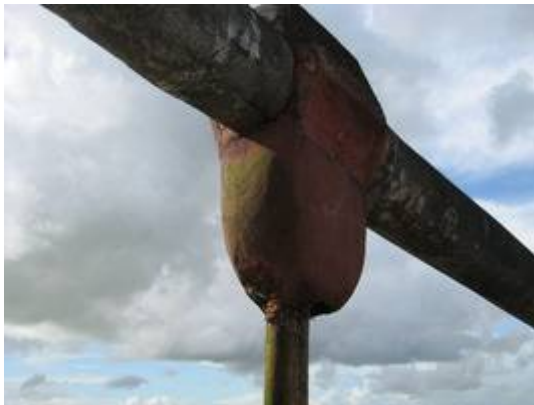
The connection between the main cable and hanger has been corrosion proofed using a material thought to be cement mortar and as shown in Photo 4.22, the main cable has simply been passed straight through the flooring. The road surface is comprised of I-type steel, and as can be seen from Photo 4.23, a simple expansion joint was used between abutments.

Photo-4.21 Corrosion proofing by cement mortar?

There are concerns over the durability of all the above and it was suggested that this bridge needs to be maintained while keeping in mind all these concerns.

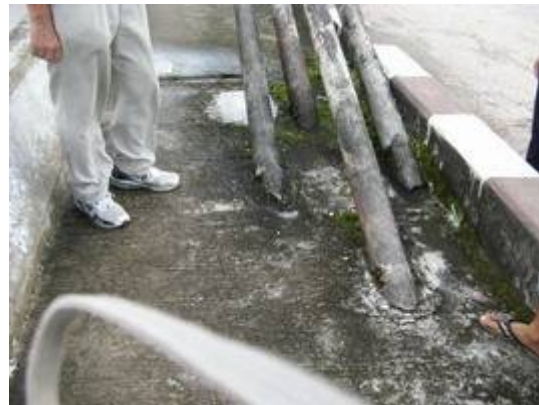
Photo-4.22 Cable passes through the road surface

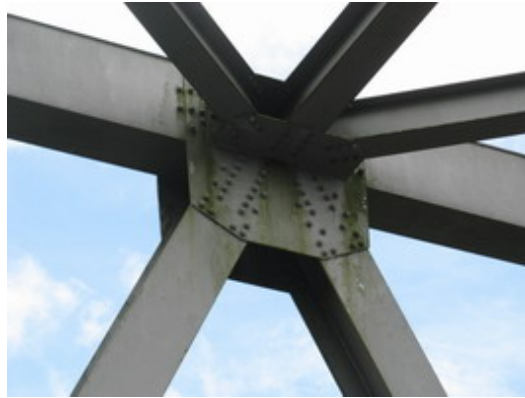
Though the 2010 survey detected rust at the truss panel points (Photo 4.33), no other degradation damage was found.

Photo—4.33 Rust at the panel point of the truss

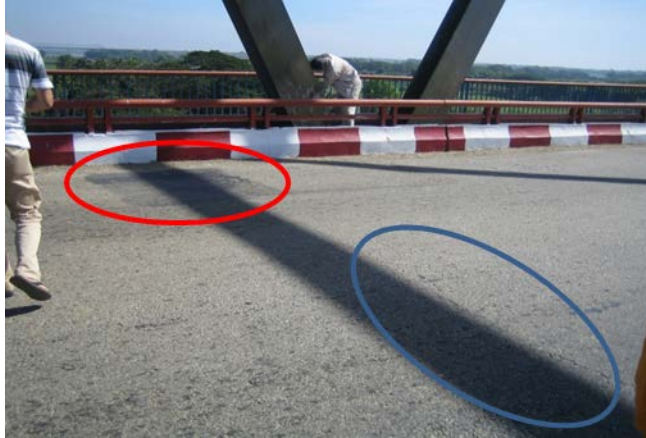
In the 2011 survey, since damage was detected in some of the asphalt pavement surface, looking at the underside of the slabs revealed evidence of repair to the slabs (Photos 4.34 & 35).

Photo—4.34 Damaged asphalt pavement

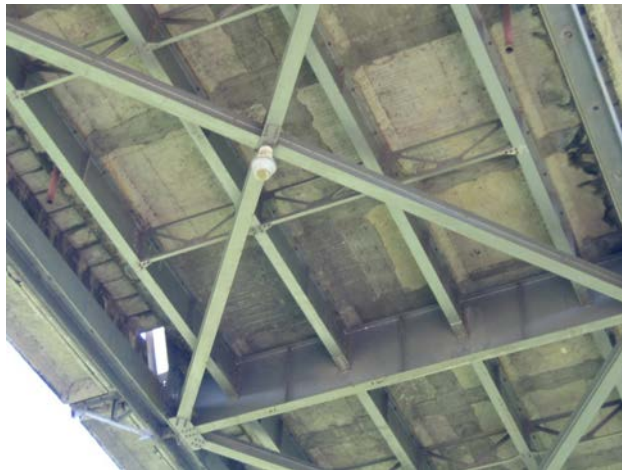
Photo—4.35 Remnants of repairs to concrete slabs

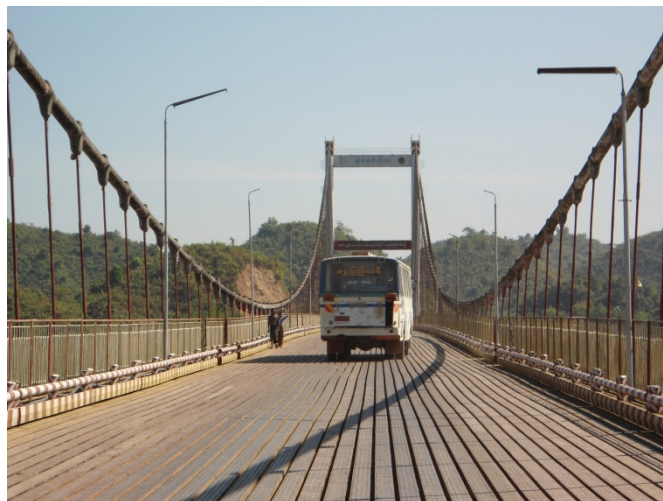
Due to the low traffic volume over this bridge, even though there are two lanes, most vehicles drive down the center of the road which has caused the molded steel of the road surface to become deformed (Photo 4.37). It would be preferable if small blocks (chatter bars in Japan) were installed along the center line to ensure the traffic to keeps the two-lane system.

Deformation of steel deck

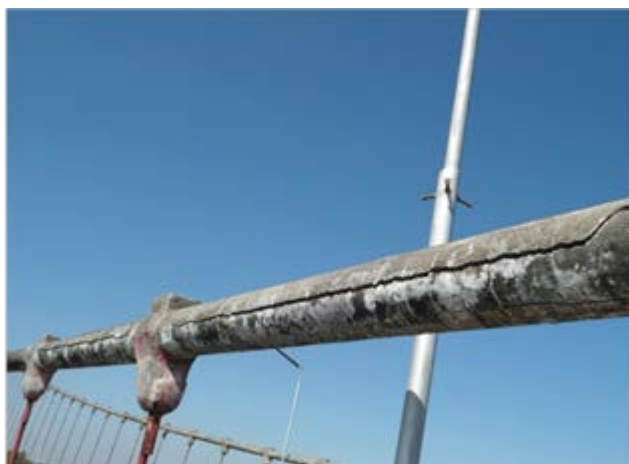
The coating of the cable has split, been chipped away, and corrosion can be seen on the exposed inner section of the cable. From the condition of the cable corrosion, the cable may not have been corrosion proofed (Photo 4.39).

Photo—4.38 Main cable cladding

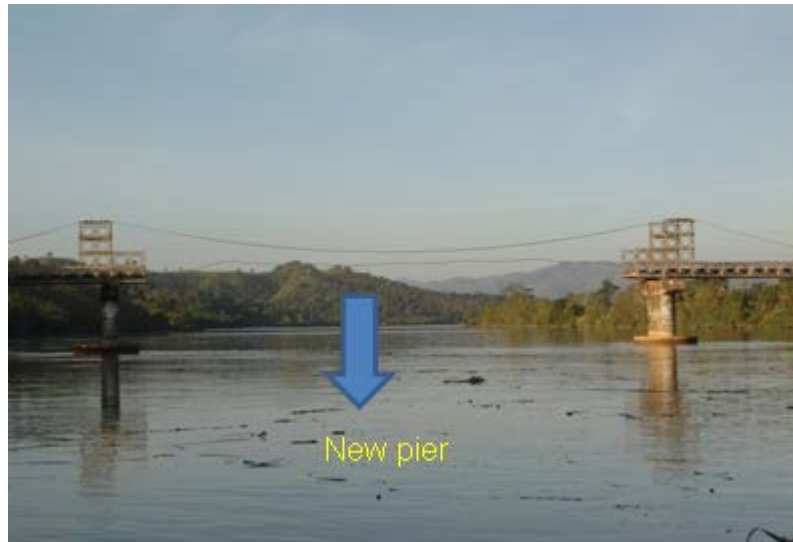
The bridge is a Bailey Bridge constructed in 1999, and is currently under repair since flooding washed away a pier in 2011 (Photo 4.40).

It appears that the open-caisson foundations were insufficiently embedded into the soft rock of the river-bed, and the pier was washed away due to scour.

Photo—4.40 Da let-Chaung Bridge under repairing

In order to avoid similar future trouble occurring due to flooding, once the cause has been sufficiently investigated the bridge should be reconstructed, and measures to prevent scour of the remaining piers may also be required.

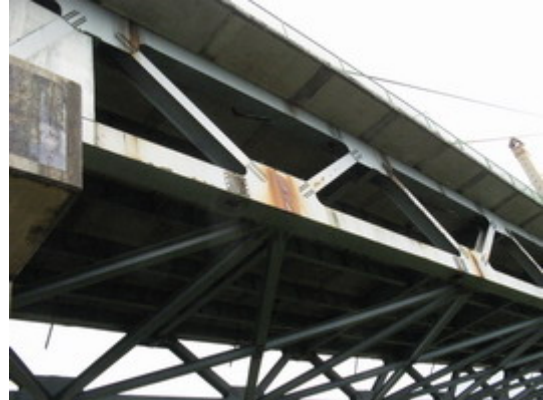
Photo-4.42 Rust due to drain water from the road surface

A drainpipe runs through the trusses from the road surface, but only extends partway (not clearly shown in the photos). Therefore drainage water runs over the trusses causing rusting (Photo 4.32 & 43). When maintaining the bridge, careful consideration at the level of design and construction is required.

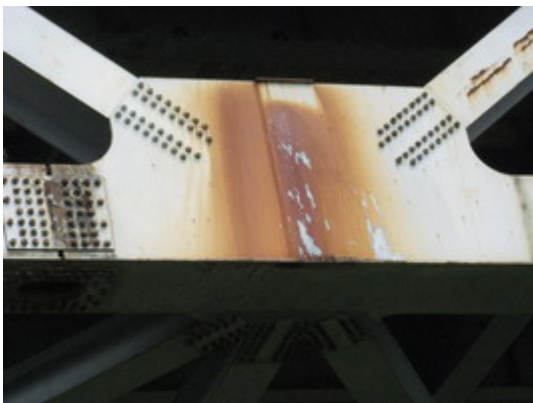
Photo-4.43 Rust due to drain water from the road surface

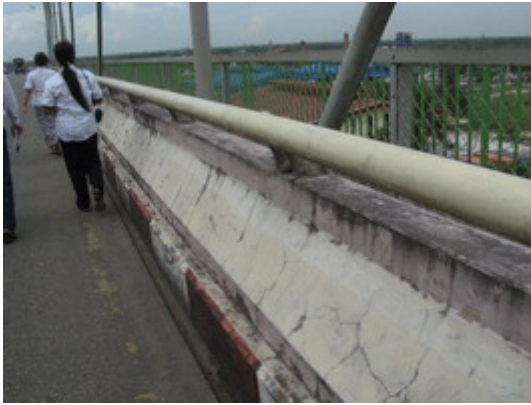
Cracks in the surface of the concrete bridge railings were seen (Photo 4.45). Since these

cracks were of a pattern commonly seen with alkali-aggregate reactions, it is suggested that the alkali causing the reaction is investigated.

Photo-4.45 Cracks in the bridge railing

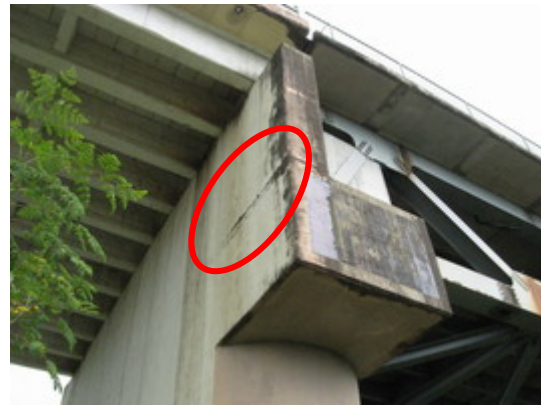
In the rear face of the abutment, cracks such as in Photo 4.46 were seen. It is suggested follow-up observation is required.

Photo-4.46 Concrete cracks

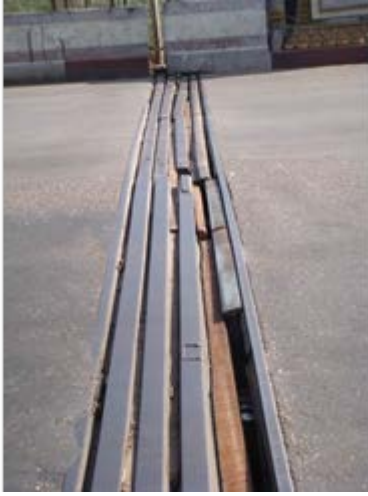
A Chinese manufactured expansion joint (an imitation of a German Maurer joint) had been used, and as shown in photos 4.47 & 48, most of the beams have fractured and support beams have simply been loaded on top, and then the beams have jumped out with the passage of traffic above.

Photo-4.47 Damage to an expansion joint

The site was inspected in June 2011 also, and it was advised it was in a state that would not be left for even a day longer in Japan. Even though it was suggested that at the very least the damaged sections of the joints should be covered with steel plating, and that traffic should be instructed to drive slowly, no action had been taken by the time of the 2011 study in December that year (when this was suggested again in the 2011 study, the damaged sections were finally covered with steel plating).

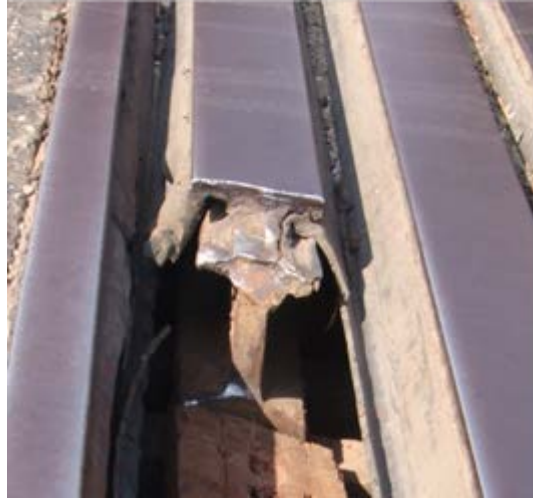
Photo-4.48 Fractured member of expansion joint

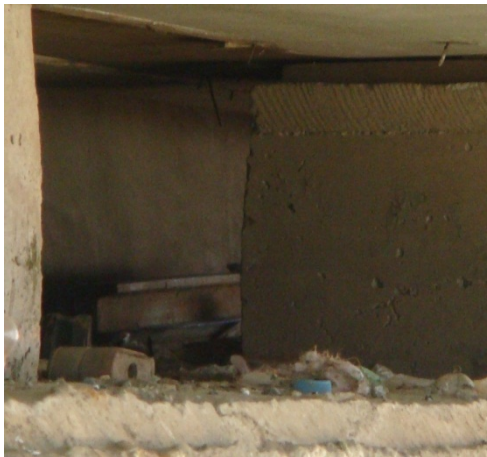
The damage has clearly worsened since PW requested repair advice in April 2011. The fractured beams have fallen on the top of the pier, and timber has been put in the vacant space (Photo 4.49).

Photo-4.49 Fractured member of expansion joint
dropped on the top of the pier

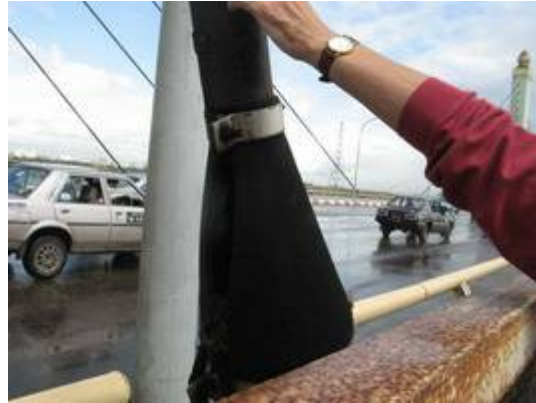
Photo-4.51 Wound cable rubber guard

Photo 4.51 shows the attachment zone to the stiffening trusses of the cable. A rubber guard has been wound around the attachment zone to prevent rainwater seepage; however it has a major fracture and is not fulfilling its essential function.

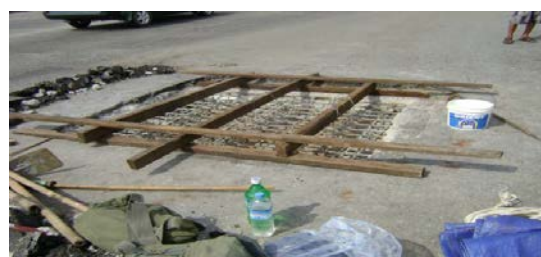
The concrete slabs of the approach concrete bridge (Photo 4.52) have been damaged several times a year over the past few years. Photo 4.53 shows the repairs to the slabs. When examining the cause of the damage to the slabs, necessary countermeasures need to be investigated.

Slab damage due to Heavy truck in Bandoola bridge

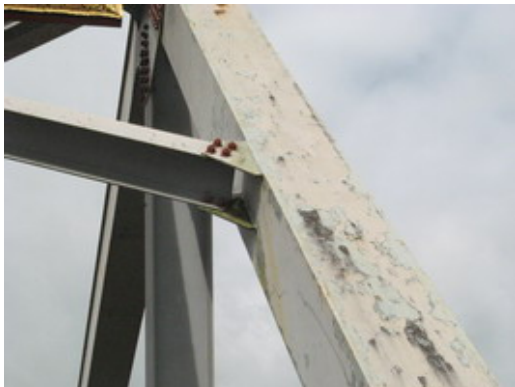
No major deterioration damage was seen in the superstructure of this bridge, though the main members of the truss and panel points have rusted (Photo 4.55 & 56).

Photo-4.55 Rust of the truss

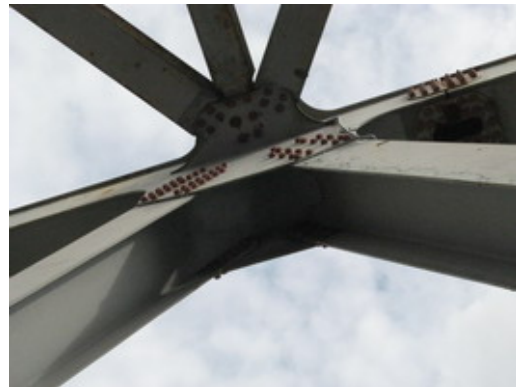
Photo-4.56 Rust of the panel point

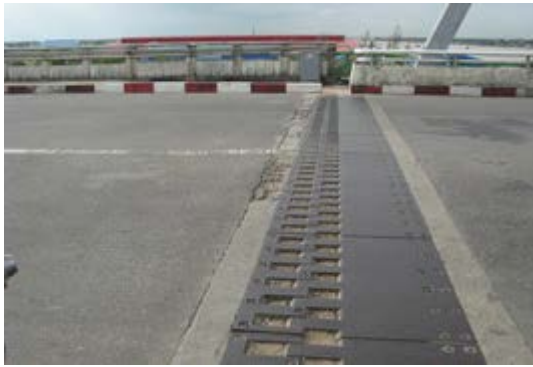
There were sections of untended damage to the expansion joint (Photo 4.57).

Photo-4.57 Damaged expansion joint

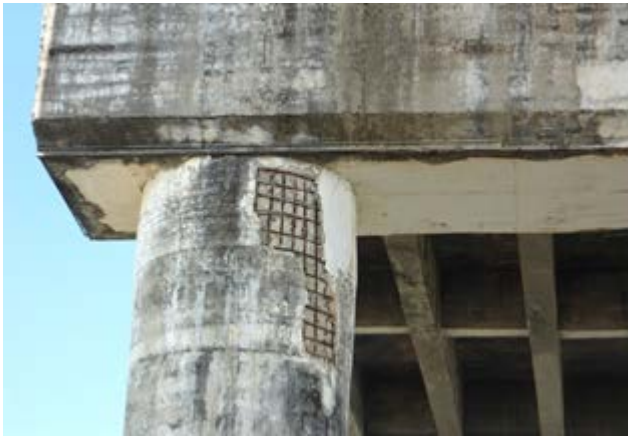
A large quantity of concrete has peeled away from the concrete pier and the rebars have become exposed and fractured (Photo 4.60). Due to major peeling of the concrete, one section has fallen off and smashed (Photo 4.61).

Photo-4.60 Damaged concrete pier

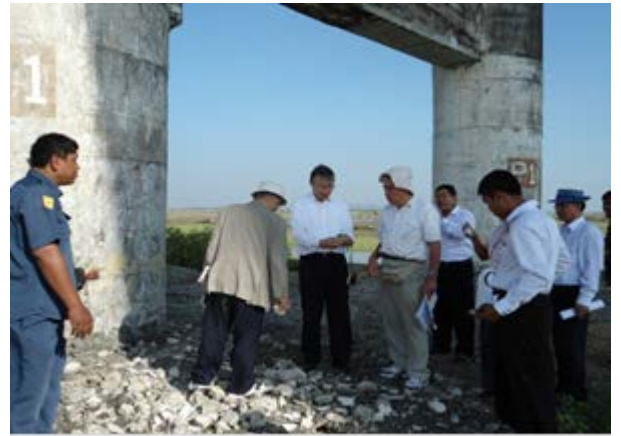
Photo-4.61 Fragments of peeled off concrete around a pier

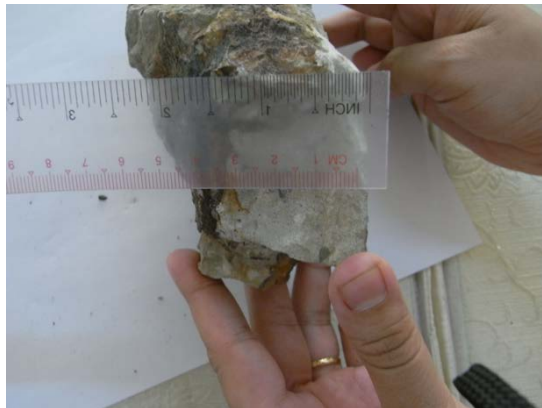
The rebars of the peeled insides have corroded and turned a black-red color which is a characteristic of salt damage (Photo 4.62).

Photo—4.62 Rebar corrosion and concrete covering

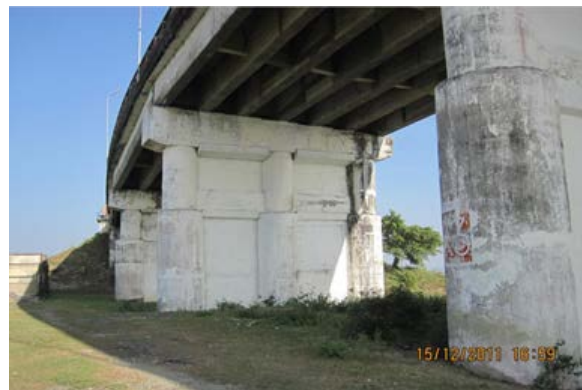
Part of the concrete pier has been reinforced using concrete lining (Photo 4.63).

Photo—4.63 Strengthening of the piers of the Min Chaung Bridge using concrete lining

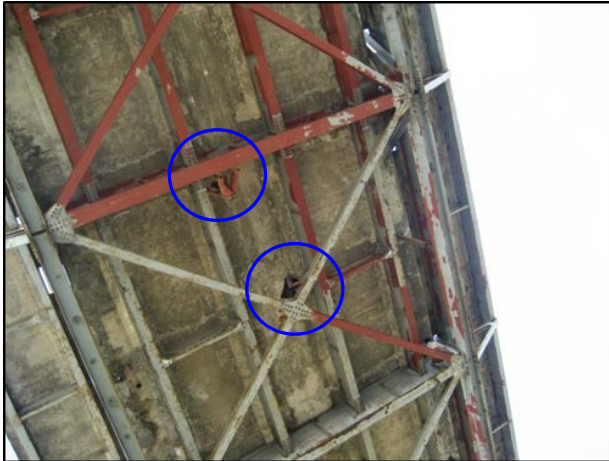
Photo-4.64 Repairing work (within the circle are workers using only a safety rope)

Not only is the number of coats applied in the repainting insufficient, with just one coat each of primer and anti-corrosive paint, (four or more coats are standard in Japan), but the anti-corrosive paint also appears to be one of low-quality that has been discontinued in Japan, and long service cannot be expected in this environment of salt damage.

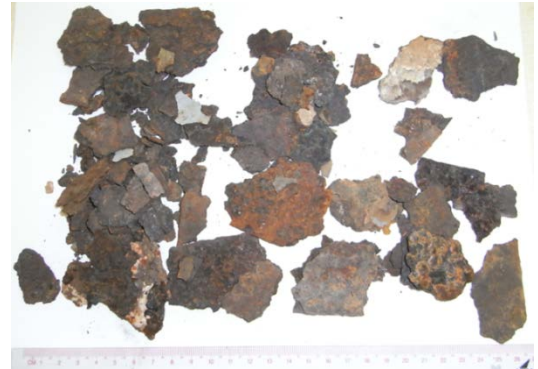
Looking at the corrosion of the steel members, the whole bridge continues to corrode, and pitting corrosion that gouges deep into the member can be seen. The rust that fell when cleaning the surface for repainting (Photo 4.64) is characteristic of salt damage, and paint film degradation and steel corrosion due to airborne salt and salty air were confirmed (Photo 4.65).

Photo-4.65 Fallen rust fragments

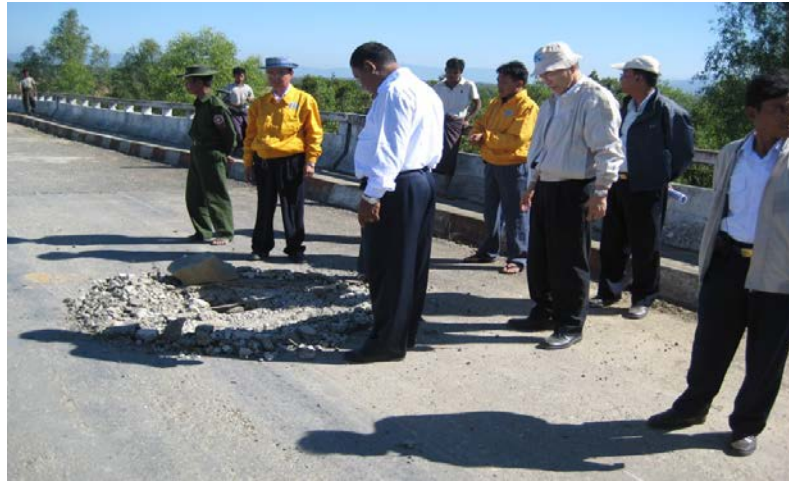
As seen in Photo—4.68, deterioration of slab has been already started.

Photo—4.68 Depression in a road surface due to damaged slabs

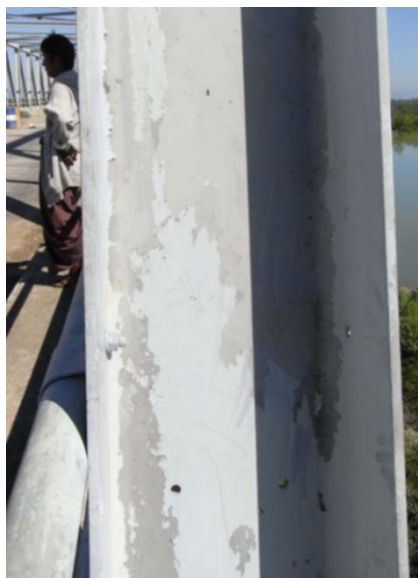
Looking at the corrosion of the steel members, as can be seen in photos 4.69 & 70, peeling of the paint film on the truss members can be seen over a wide area. Peeling of the paint film suggests that the paint itself has low adhesive properties, and the cause of the peeling requires investigation since the total destruction of paint film is regarded as a warning.

Photo-4.69 Peeled paintwork of the truss

In some areas of peeling the film thickness is less than half, and since the anti-corrosiveness of those areas is greatly reduced, repainting (recoating) is urgently required as soon as the cause of the peeling is found.

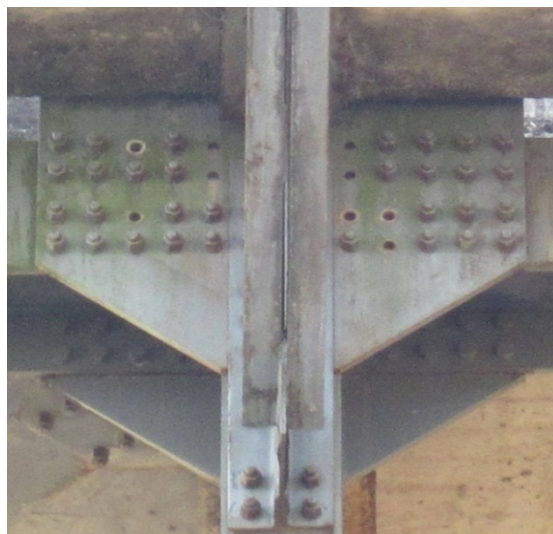
In addition, fractured high-tension bolts due to what was believed to be delayed fractures were seen not infrequently (Photo 4.72). It is suggested that in order for future countermeasures to be taken, bolt quality should firstly be tested, and the bridge's manufacturer should be informed to consider future countermeasures.

Photo-4.72 Deficit of bolt at truss splice plate

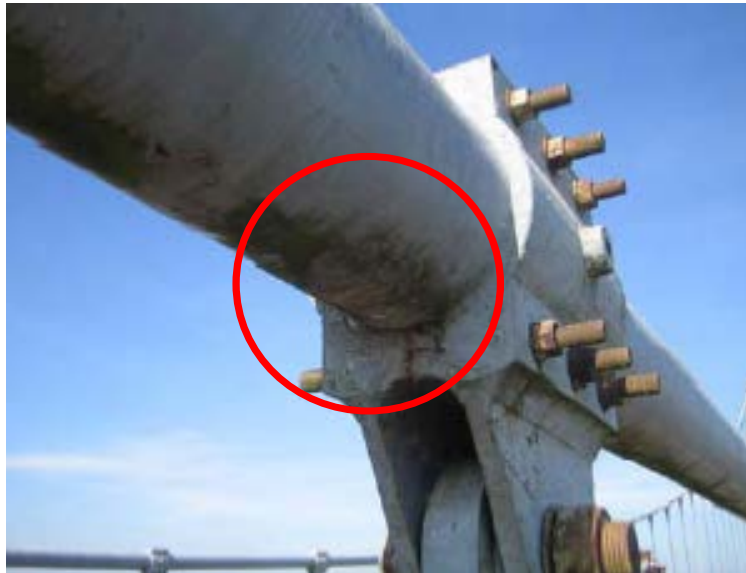
Looking at the corrosion of the steel members, water is moving around inside the material of the main cable wrapping, and a water channel can be seen in the underside of the cable (Photo 4.73). When such phenomena occur, it is highly likely that internally the cable wire is corroded. The diagram notes no materials for corrosion proofing, and it is possible that the protective layer is of inferior quality.

Photo-4.73 Water trace at main cable lapping

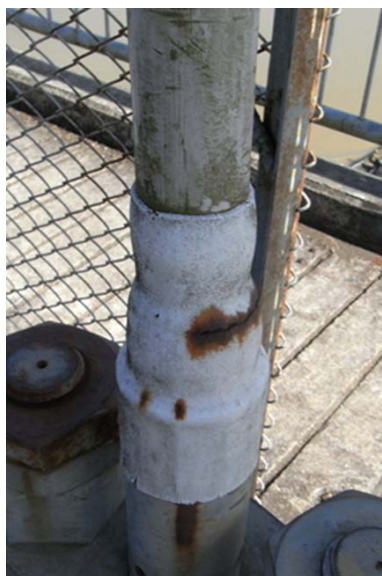
Corrosion in the protective layer of the hanger can also be seen (Photo 4.74). While the protective layer used fiber reinforced polymer (FRP) concrete, it is coming away and breaking and requires urgent repair.

Photo—4.74 Breaking and peeling of the hanger's FRP covering

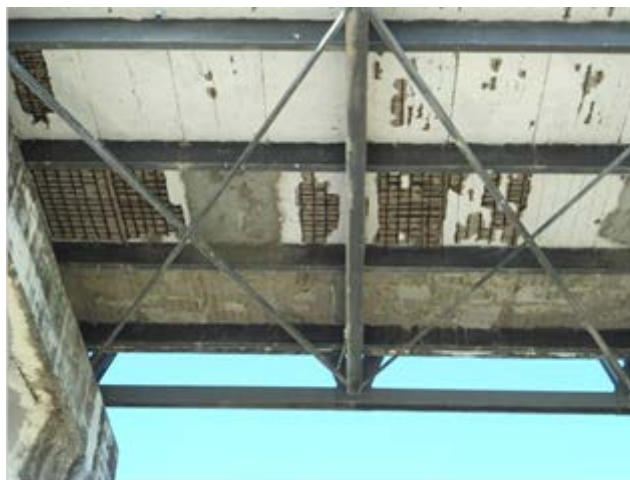
However, as for the concrete slabs of the truss section, as shown in photo 4.76, the covering concrete of the concrete precast slabs used for the underside of the slabs is falling away. This is thought to be because seawater was used in the manufacture of the precast slabs.

Photo—4.76 Damaged precast concrete slabs

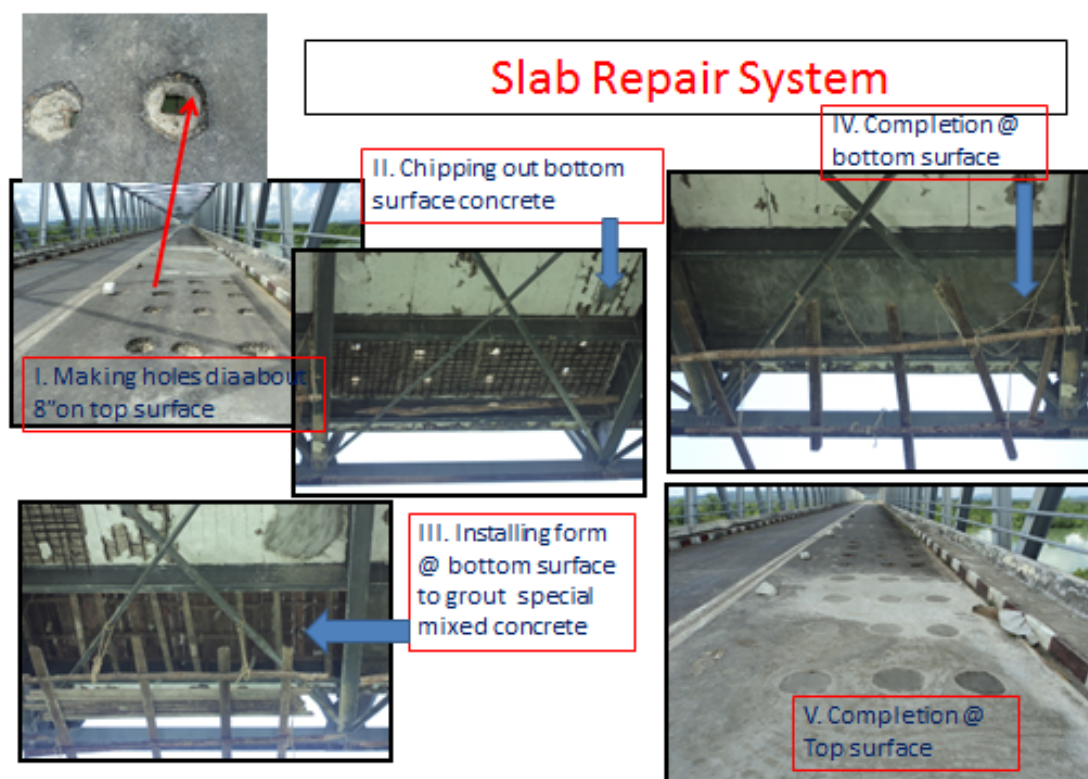
Photo-4.77 Explanation photos for slab repair work

It appears that the precast slabs have been removed, and the concrete of the underside of the slabs has been replaced, but for reasons entirely unknown, many holes have been made in the road surface.

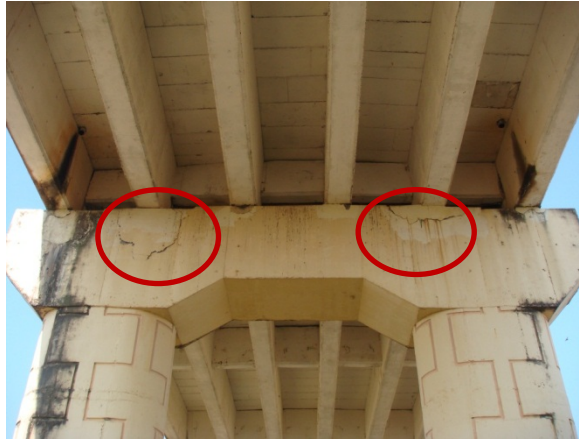
Photo—4.81 Concrete peeling of the cross beam of the H5 pier

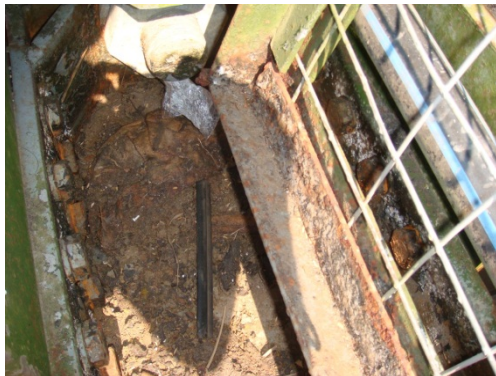
As indicated in photo 4.82, the hanger rope and truss top chord are joined with bolts, though the bolt-heads are corroding. It is suggested that drainage holes are urgently bored in the truss and the bolts are anti-corrosion proofed (it was also suggested in the 2010 survey to bore drainage holes, though this has not been implemented).

Photo-4.82 Corrosion of the hanger rope attachment

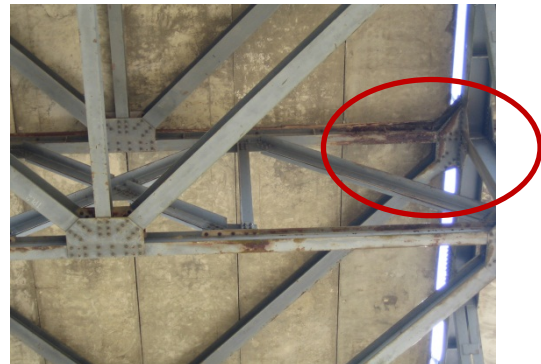
Similarly, as shown in Photo 4.83, the truss top chord is seriously corroded, so it is suggested that similar anti-corrosion proofing is required, and a creasing structure (water cutting structure) is proposed for the underside of the end of the slabs.

Photo-4.83 Corrosion of the top truss chord

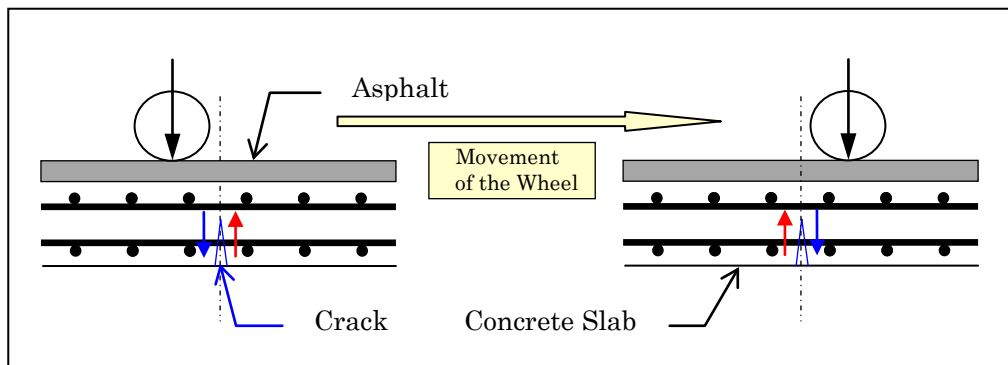
Figure—5.6 Cause of the deterioration of concrete floor slab of the bridge

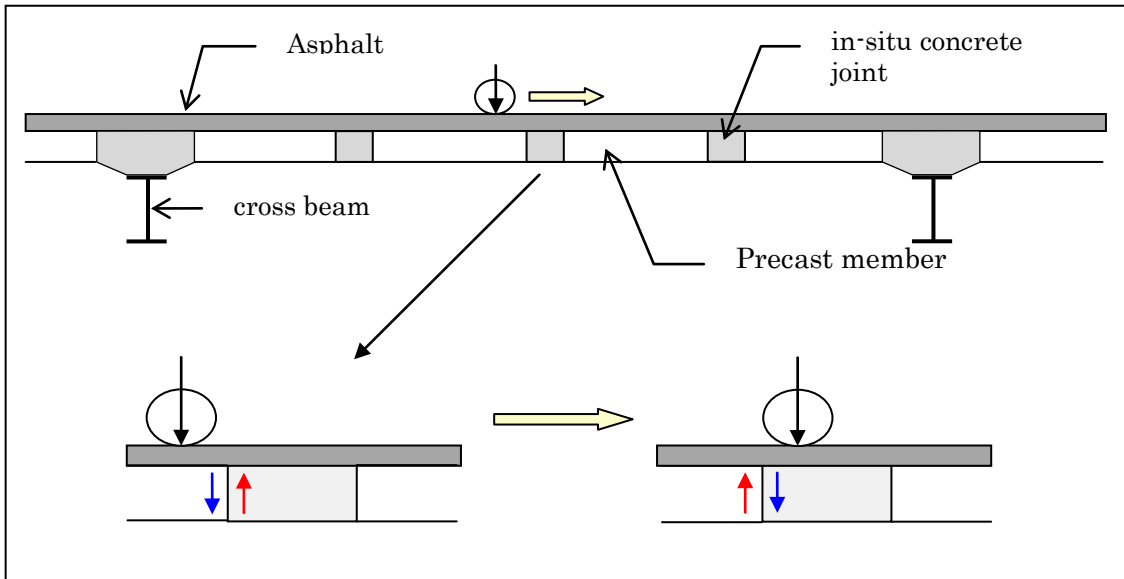
Figure—5.7 Deterioration of the in-situ joint of a Type III slab

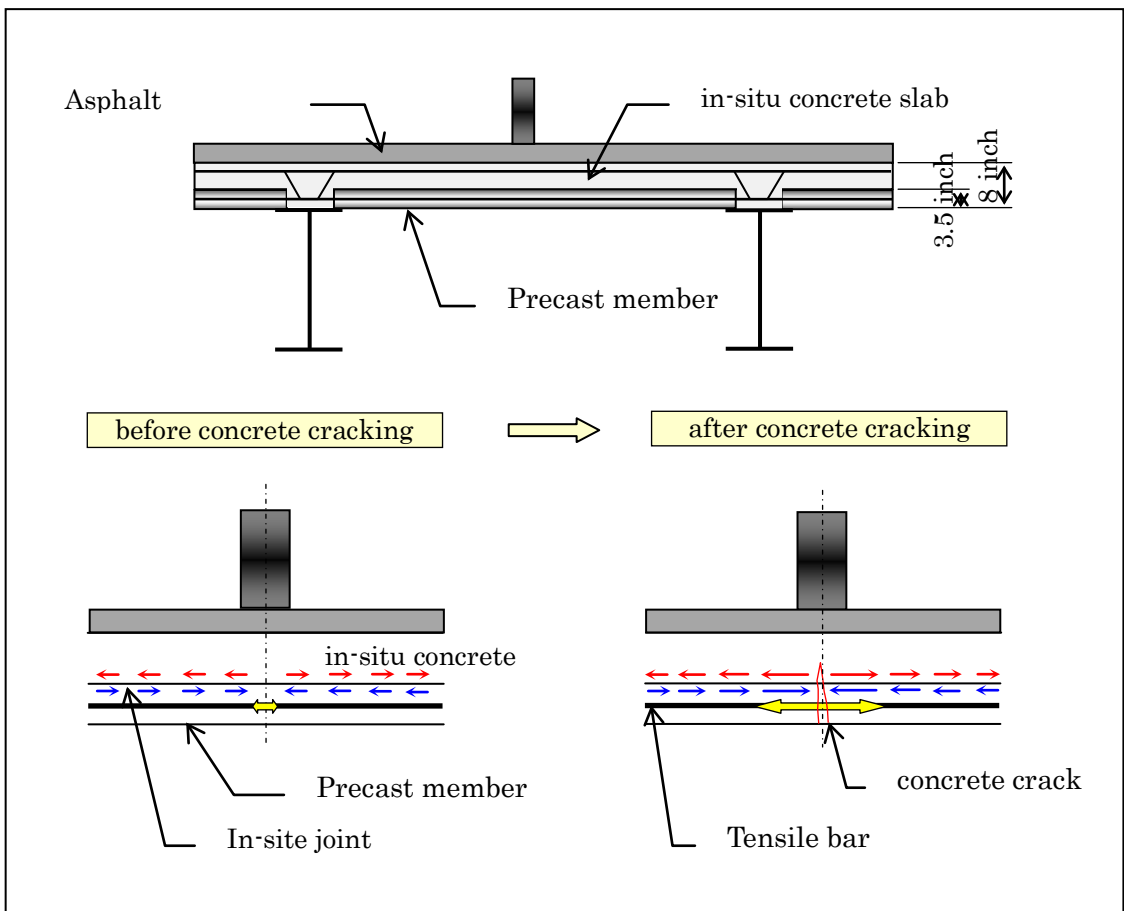
With the Type IV slabs, when cracks appear in the concrete, major stress is exerted on the face between precast panel and cast-in-place concrete and the bond between them must be damaged by the repeating traffic load, and the integrity of the precast panel and cast-in-place concrete is lost and it is no longer able to function as slab (Fig 5.8).

Figure—5.8 Deterioration of the in-situ joint of a Type IV slab

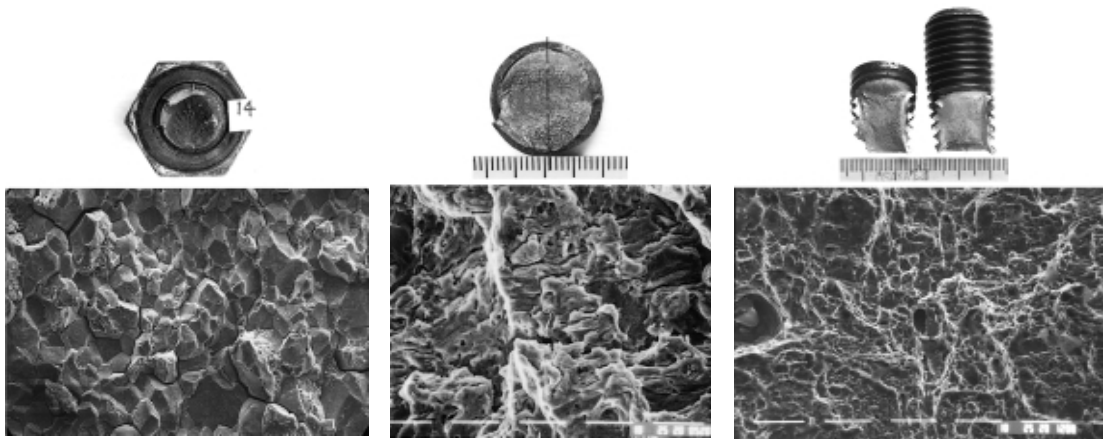
Photo—5.6 Types of fractured surfaces of bolts
